# **NATIONAL TRANSPORTATION SAFETY BOARD**

## **RAILROAD ACCIDENT REPORT**

**FIRE ONBOARD AMTRAK PASSENGER TRAIN  
TRAIN NO. 11, COAST STARLIGHT  
GIBSON, CALIFORNIA  
JUNE 23, 1982**

NTSB / RAR-83 / 03

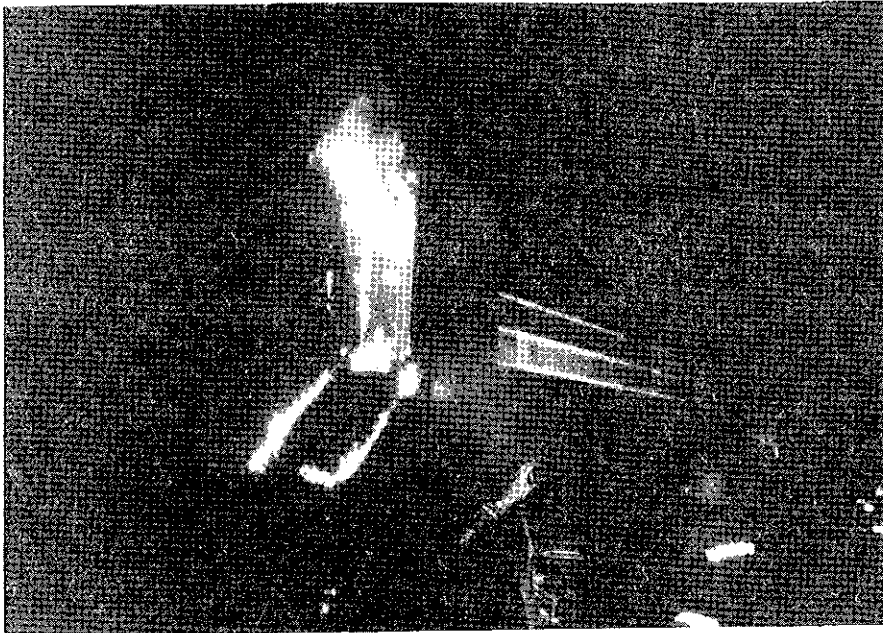
engineer said the flames broke through the car "long" before the firefighting equipment arrived. (See figure 5.)

Figure 5.--View of front end of the 1130 car during fire.

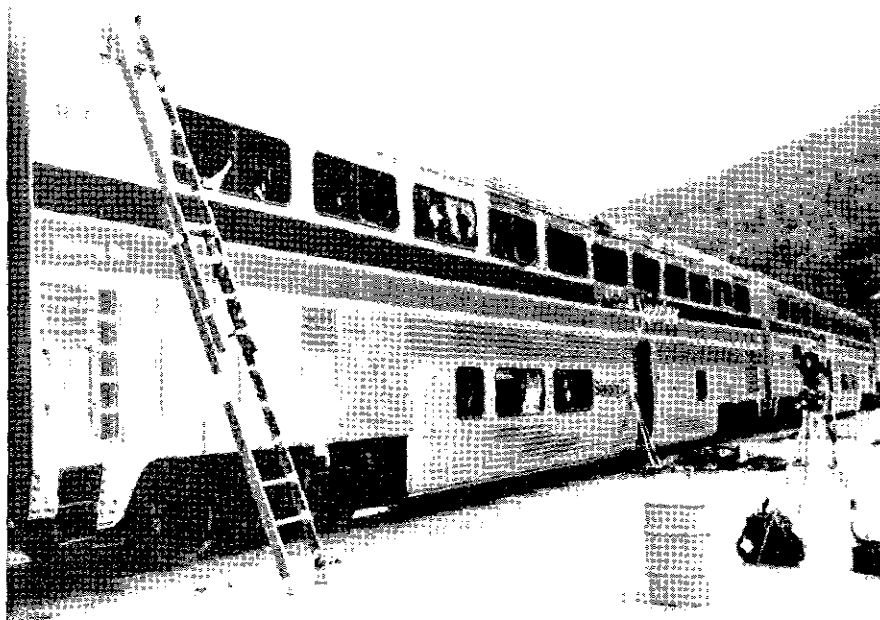
The upper level of sleeper car No. 32010 (1130) was destroyed; the lower level was damaged by the intense heat and smoke. (See figures 6, 7, and 8.)

Figure 6.--Exterior view of the 1130 car.

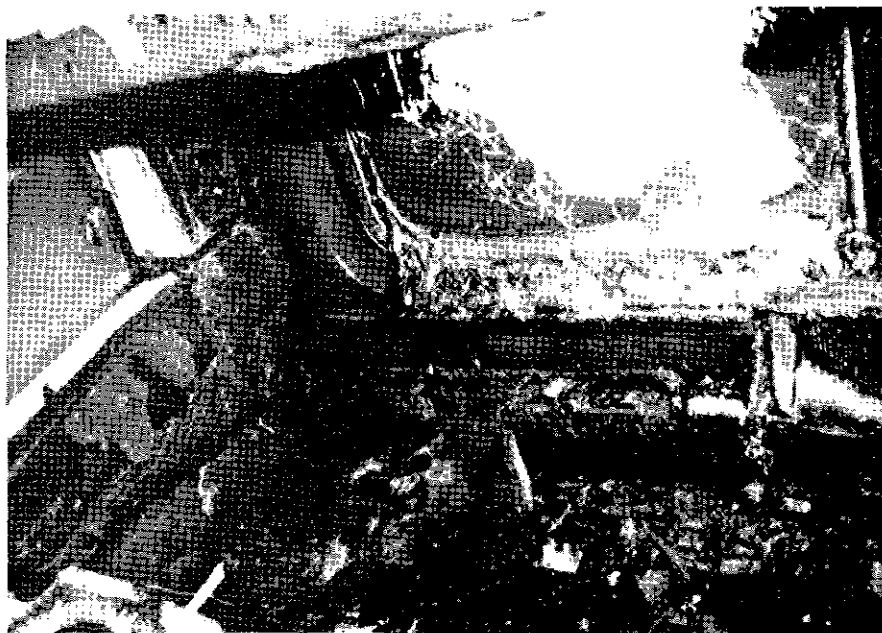
Figure 7.--Interior view of burned economy-type bedroom in the 1130 car.

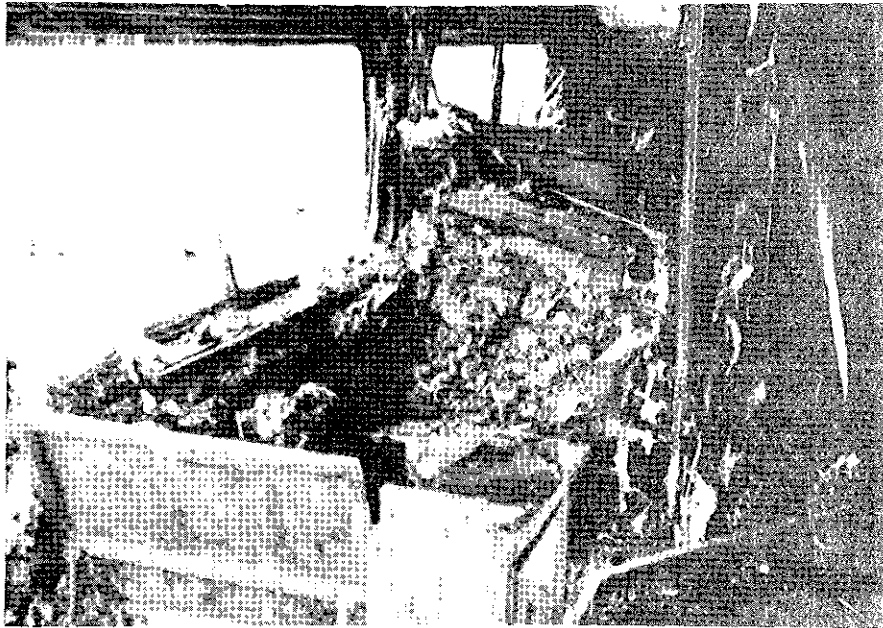
Figure 8.--Interior view of burned economy-type bedroom in car 1130.
